## More Joys of a Lofrans Tigres Owner

As I mentioned in the last article, servicing my Lofrans Tigres had become a bit of a priority as my previous neglect had led to a few issues.

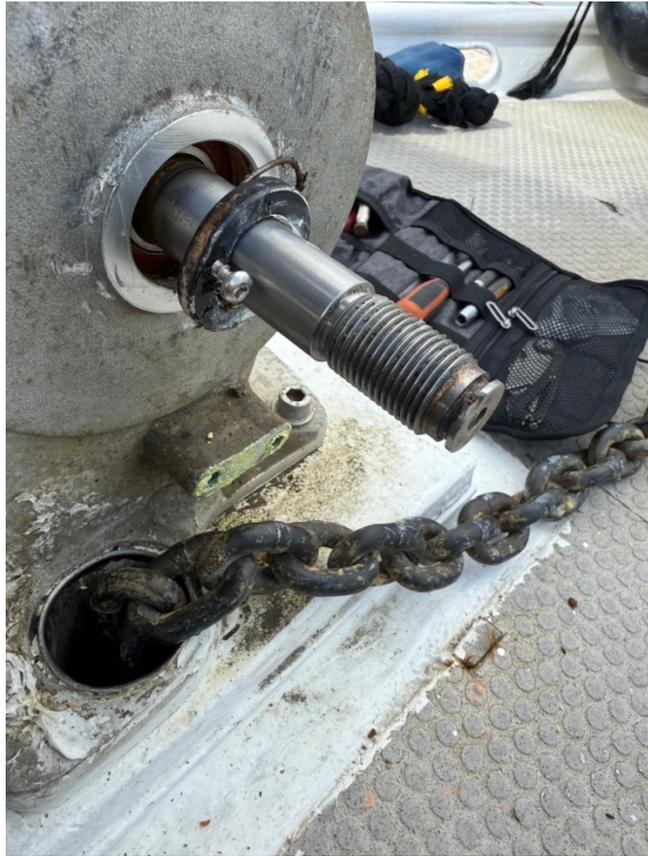
*Rather than scar the housing whilst trying to remove the seal, I find drilling a small hole and screwing in a self-tapping screw allows the seal to be pulled out (fairly) easily.*

If you're planning a similar exercise, the seals either side of the gypsy and drum are 25x42x7TC, the inner bearings were 6005LLU, and the large O-ring that sits inside the cover on the drum side was coded BS247.

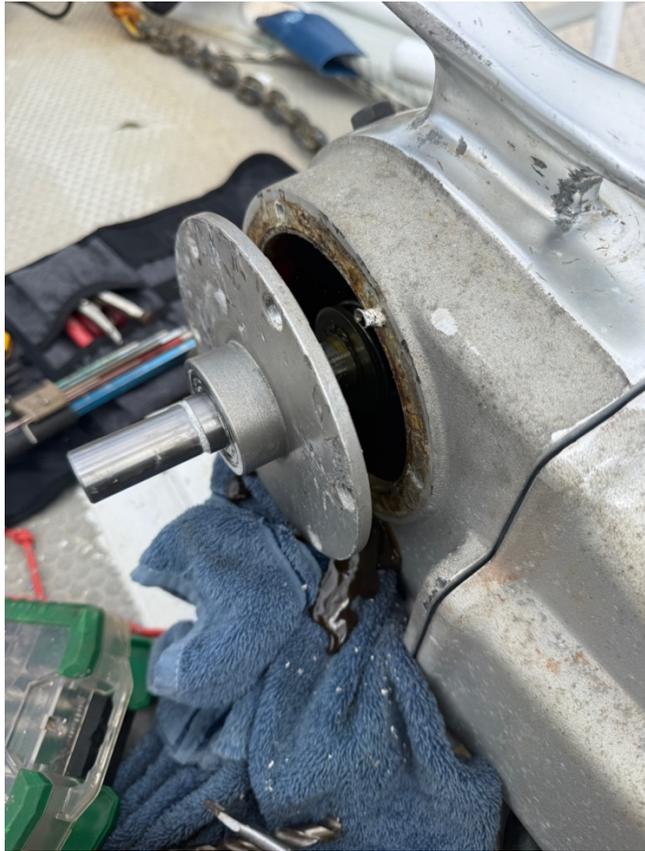
*A rounded off machine screw. Luckily, I was able to drill out the head and remove the remainder with mole grips.*

Of course, when I got past the point of my last tear down things started getting a little harder to take apart. The situation everyone dreads is the bolt or machine screw that refuses to budge. The cover on the drum side has six machine screws, so it was inevitable that one would refuse to play ball. This particular screw's allen key socket rounded off oh so easily, and I was left to contemplate how much of a PITA my ham-fistedness was going to create. After trying other bits to see if any would grip, I had little choice but to drill the head off the screw. Amazingly, this was a straight forward exercise, and with the head removed I was able to take off the plate and remove the remaining piece of screw with mole grips. Of course, oil will start to leak out as soon as the seal is disturbed, so have a container ready. Feeling fortunate that the machine screw hadn't snapped off inside the aluminum housing, I decided to replace all the screws and clean the housing's threads with a tap.

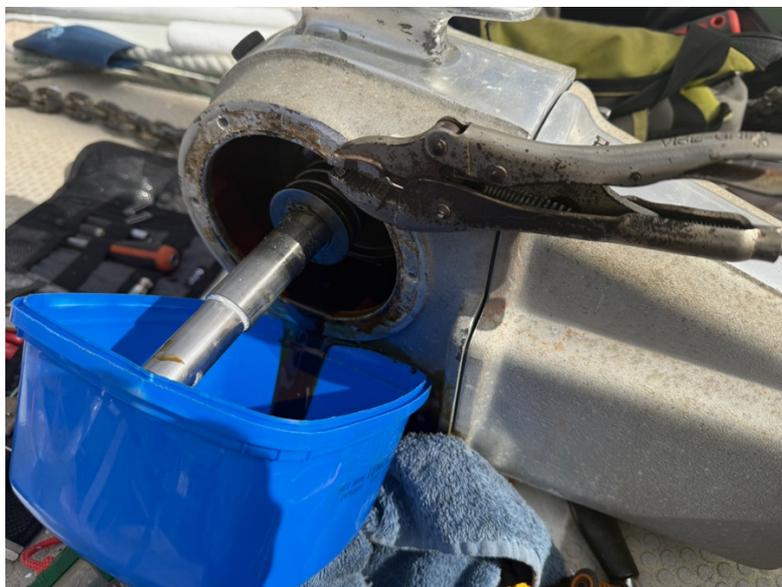
*Escaping oil, a broken machine screw, and mole grips to the fore. A typical day at the office.*

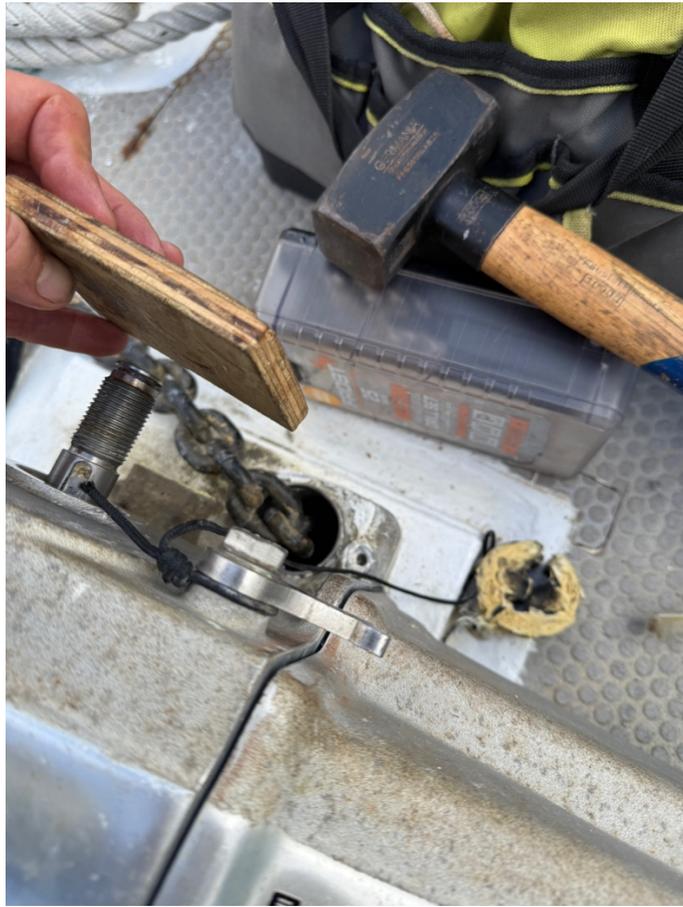
*Tap the shaft out.*

At this point of disassembly, I was able to drift the lateral shaft out from the gypsy side. You can see that I used a piece of scrap plywood to protect the end of the shaft from the gentle ministrations of my lump hammer.

Due to the interaction between the gear on the shaft and the worm gear that runs fore and aft there is some resistance to the shaft being tapped out. I was loath to use brute force to overcome this — but, having read other peoples' accounts, scratched my head, and come up with no better plan, a bit of force seemed the only way to proceed. Fortunately, the shaft came out fairly easily.

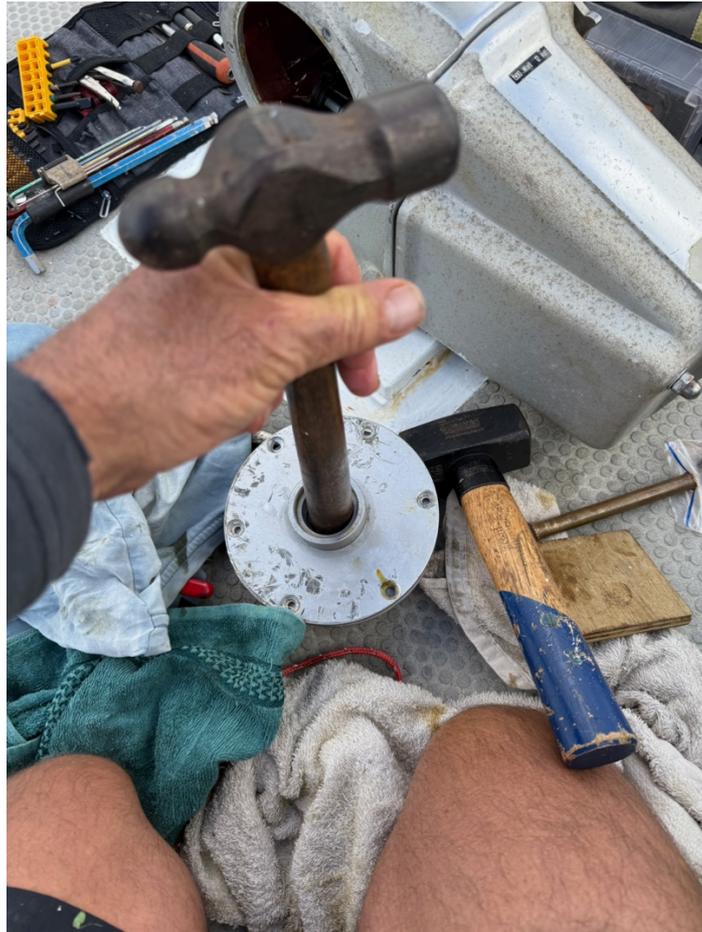
*I used the gypsy below the housing to help ease the bearing out.*

With the shaft out I tapped free the bearings and could finally see clearly into the windlass' interior.

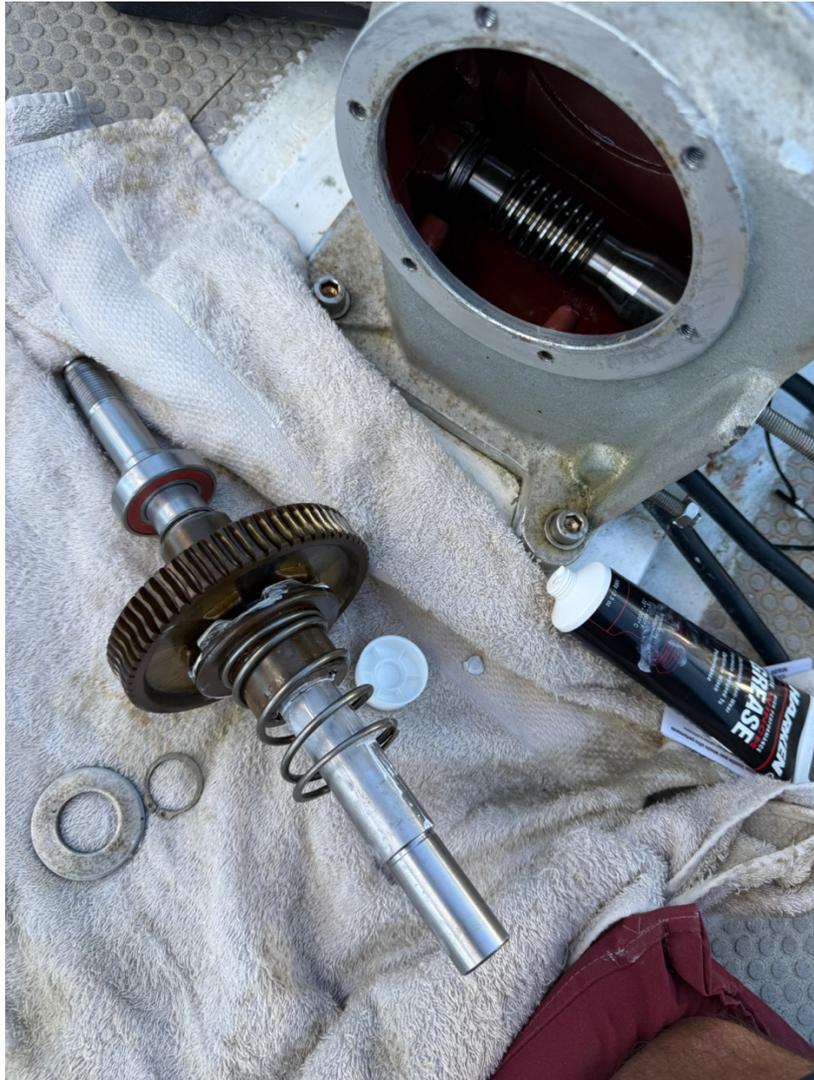
*Shaft free. Note the worm gear still in the housing. I've started to strip the shaft. The spring creates some tension on the circlip, but not a great deal. Make sure it doesn't fly overboard!*

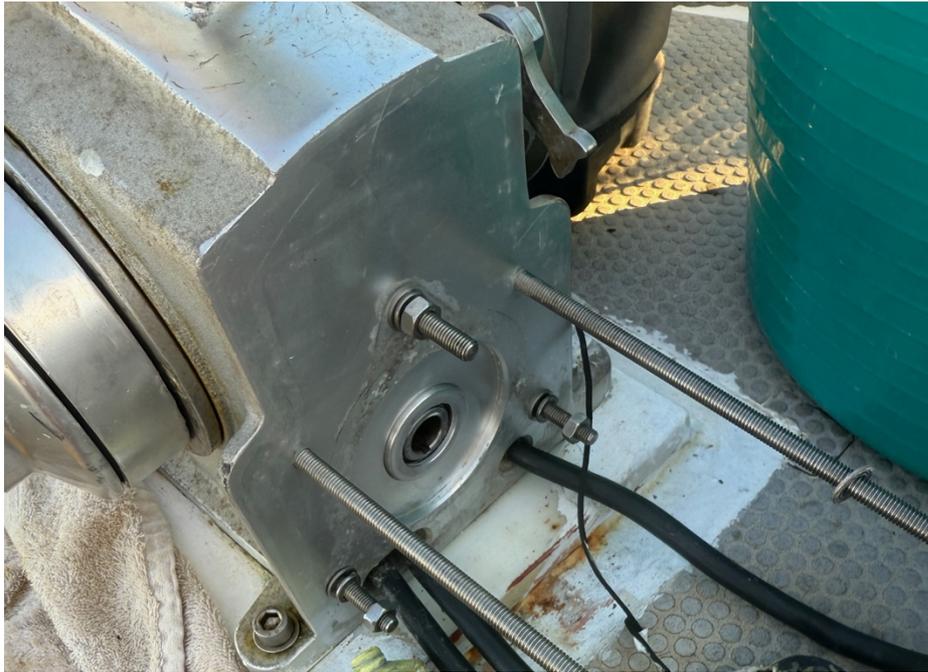
*The spacer in the rear of the housing.*

With the motor removed you will be able to see a spacer in the housing (photo below). I was able to take out the worm gear shaft by pulling it rearwards via the now removed inspection cover, the spacer popping out with it. BE AWARE if you take this step (I only did mine because the oil inspection glass was so dirty that I couldn't see through it) that there are three thrust bearings on the shaft with rollers that are not caged. As you remove the shaft they will try to escape!

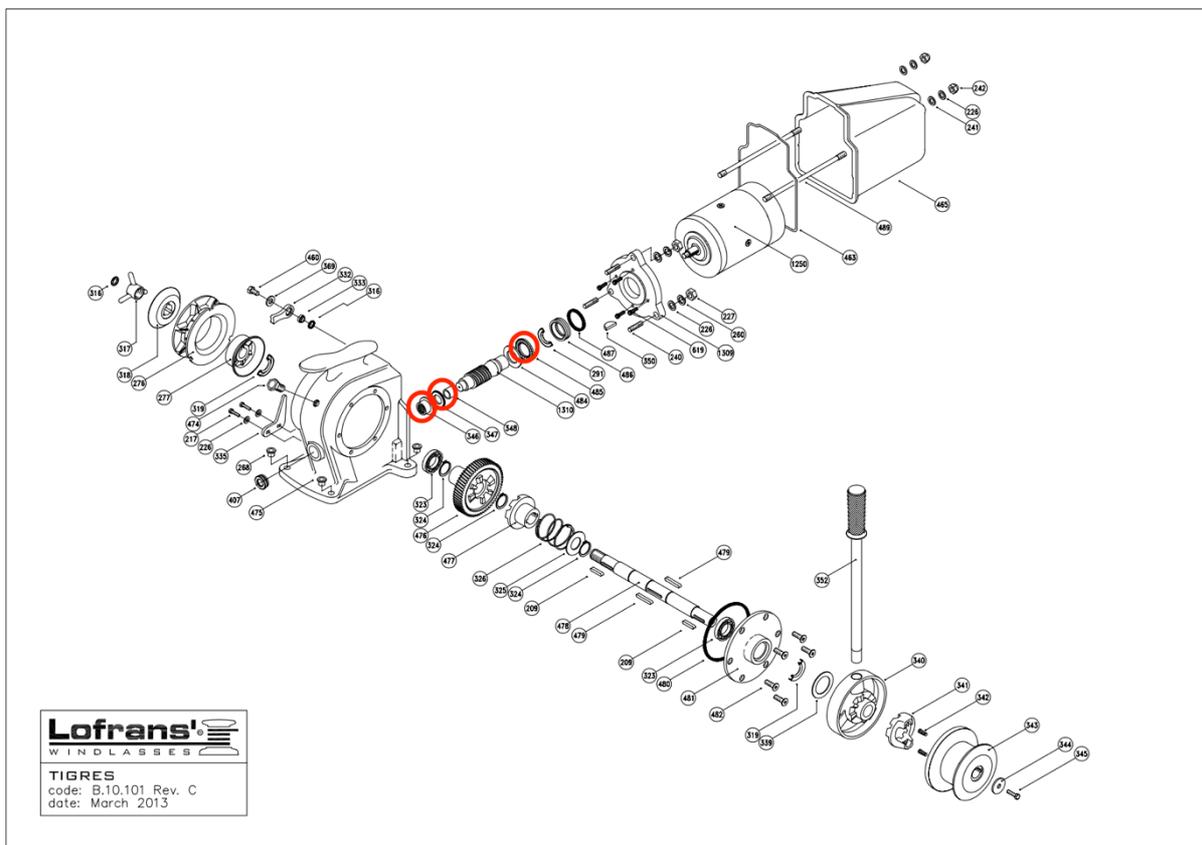
**Lofrans**  
WINDLASSES  
TIGRES  
code: B.10.101 Rev. C  
date: March 2013

*Note the position of the uncaged bearings that may spill...*

After cleaning and greasing everything lightly the re-installation is the opposite of the strip down. The exploded diagram Lofrans provides (see above) is helpful, and it's a good idea to follow it carefully because if you forget one of the circlips everything has to come apart again (believe me, I know).

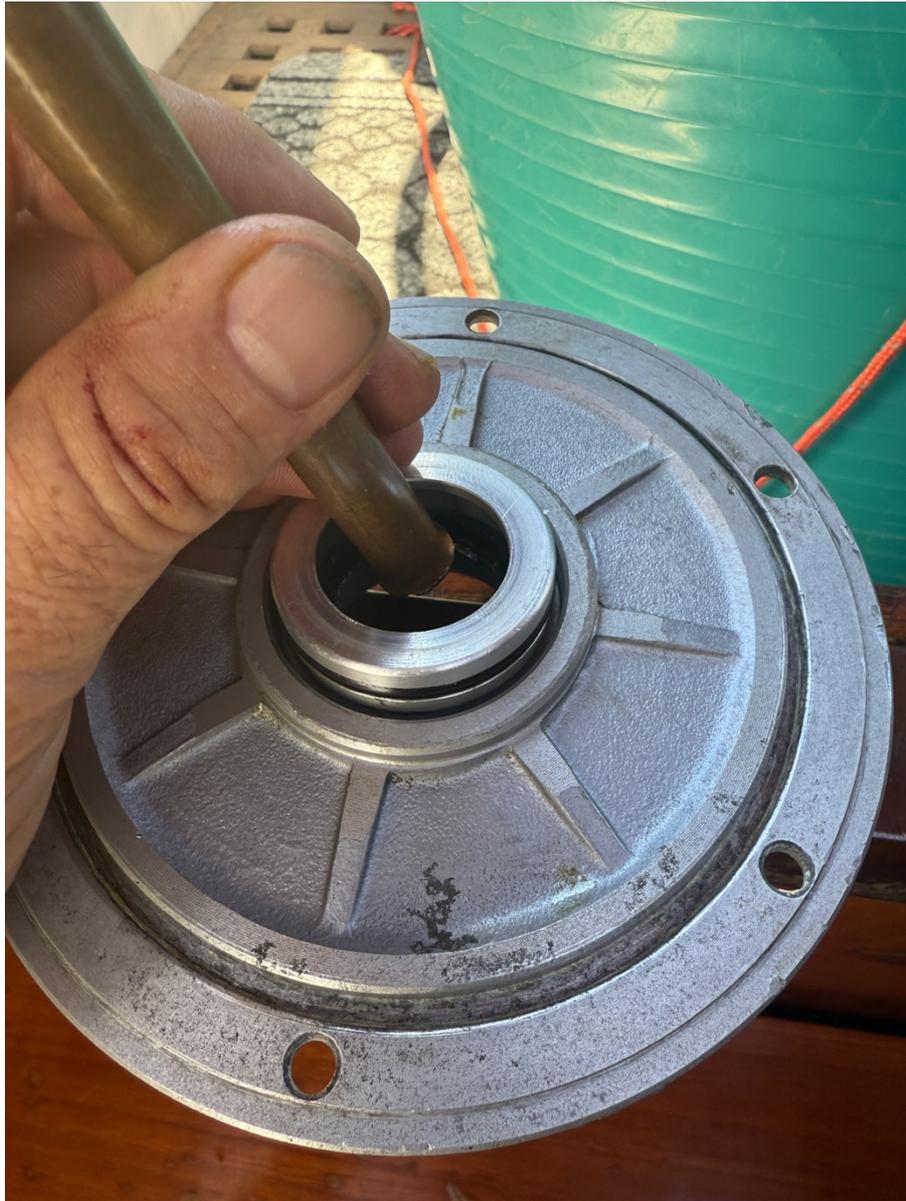
*Here I'm tapping the oil seal out of the spacer with the help of the side cover.*

With the shaft removed, and roller bearings recovered, you should note that the spacer is made up of three parts: an O-ring, an oil seal, and a chunk of aluminium that houses them. The O-ring and seal are coded BS222 and 25x35x7TC respectively.

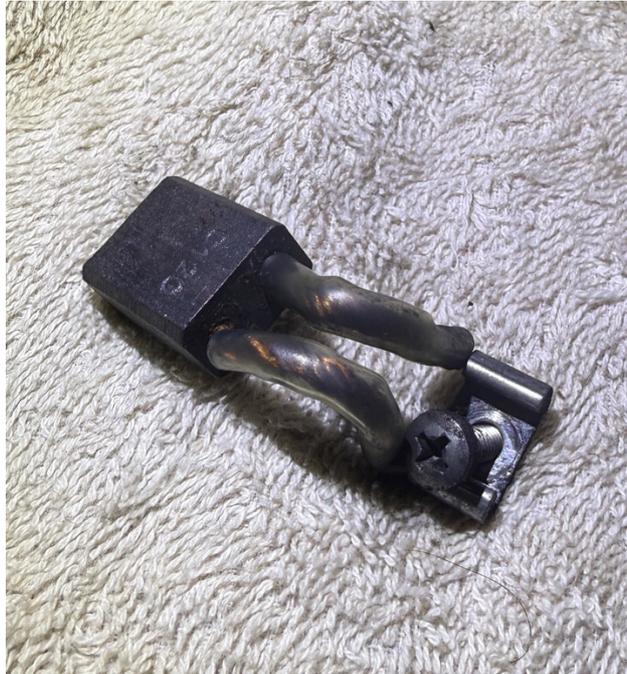
*One brush — A\$62.50 worth.*

The brushes are marked 'C12G' and measure 16mm by 9mm by 19.5mm (the latter including the wearing face). If anyone knows of a brush that might suit, please let me know!
